Qantas maintenance crews now work on a safe, bright floor that resists chemicals

Client: Qantas

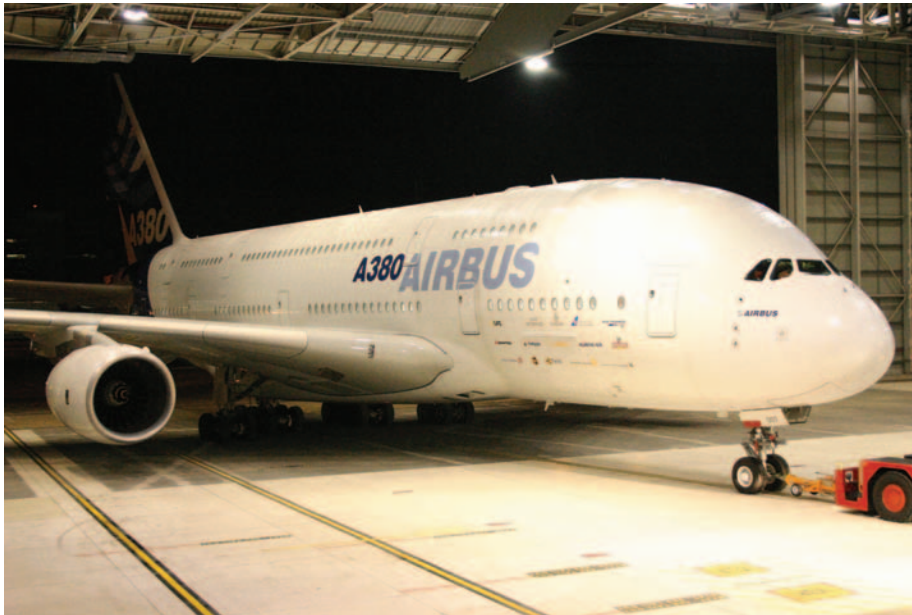
Problem: Plain concrete and damaged jointing, low light reflection and a hard-to-maintain, porous, concrete finish. Also the line-marking has failed to stand the test of time.

Spills, low reflectivity, poor traction and faded line-marking have been replaced by a high performing floor that makes for a more pleasant working environment for Qantas maintenance crews

Solution: Environmentally-sensitive preparation of the surface, repair works and a light-reflective finish resistant to chemicals (specifically, Skydrol, an hydraulic aviation fluid). New line-marking and floor signage, all with an anti-skid profile.

- Prepare surface by degreasing and captive waterblasting, followed by captive shotblasting
- Complete repairs using a high

strength, two-part epoxy

- Apply two-part, heavy-duty epoxy finish
- Complete all line-marking and floor signage to specification.
