**Achieved:** Extend life of ageing car park decks

**Client:** Roselands Shopping Centre

**Place:** Roselands, NSW

## How to give one of the world's earliest mall car park decks a new lease on life

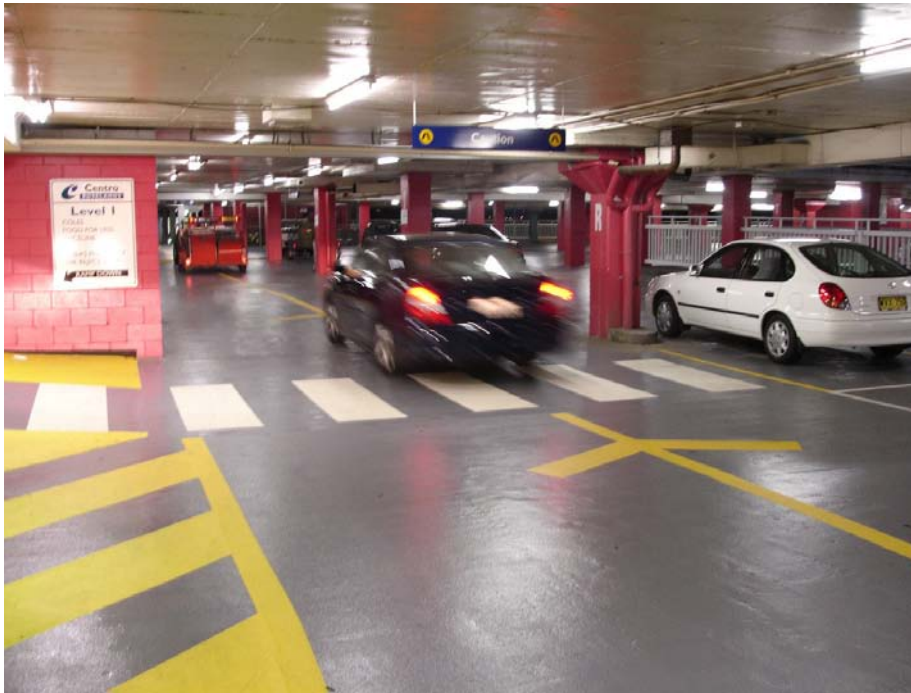
**PROBLEM:** Four decades of heavy wear of the 13,250 m<sup>2</sup> Red Level car park deck. Concrete cover insufficient to guard against corrosion. Deck flexure cracking allowed water carried in on tyres to get to the reo. Resulting "concrete cancer craters" jolted shopping trolleys, was uncleanable and tracked grime into the Centre.

**SOLUTION:** Clean the surface. Repair damage. Apply protective coating system.

**MATERIALS:** Polyurethane mortar, flexible to tolerate flexure of the deck without cracking. Deckshield ID system. Ramps Deckshield HD with 1 mm silicone carbide for high tyre traction.

- Lay 150 m<sup>2</sup> sample; contract based on 12 months site tests showing no damage, wear, cracking or delamination.
- Use high pressure water to remove the surface contaminants adopting a "clean and capture" method.
- Diamond grind to remove the poor finish and shot blast.
- Cut out damage and the rusty reo.
- Apply the three-layer Deckshield ID system to the deck and Deckshield HD system with silicone carbide grit on the ramps.
- Line-mark including a one-way outer loop connected crosswise with two-way lanes to improve traffic flow.

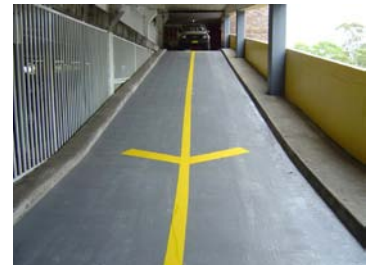
**RESULT:** Now Red Level is easy to clean. No dirt tracked into the Centre. No more jolted trolleys. Higher reflectivity boosts the light level. 10 year warranty.

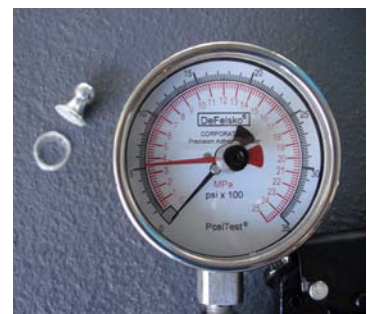
*Ramps (top) had silicone carbide grit embedded in a heavy-duty Deckshield system for traction.*

*Tests (bottom) were done by Dynamic Flooring Australia to ensure adhesion.*
